# Accessible EV Europe Road Trip

## The Route to Accessible EVs

**Project Representative:** Anjna Patel MBE  
**Project Planning, Media & Project Support:** Zoe Rush  
**Project By:** Disabled Motoring UK (DMUK)  
**Project Completed:** May 2026  
**Published:** July 2026

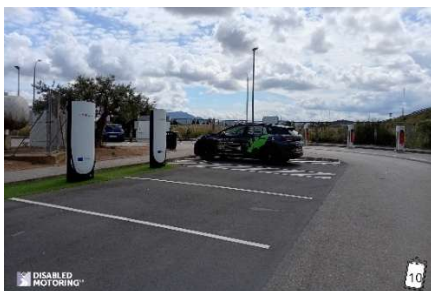
| Accessibility thoughts - Following failures at two previous charging locations, this site successfully enabled charging and demonstrated the importance of reliable infrastructure. Although the charger ultimately met our needs, the journey highlighted the challenges disabled EV drivers face when alternative charging locations are unavailable or out of service. | | |

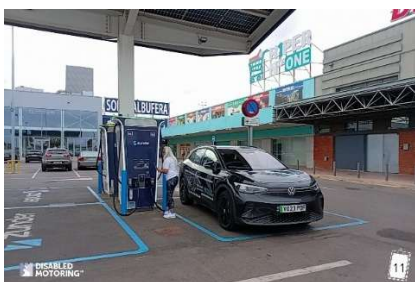
| Accessibility thoughts - The Tesla charging location proved to be a simple and effective alternative after difficulties using another network. Accessibility is generally good, with a dropped kerb nearby and a straightforward charging process. However, there are no designated accessible charging bays, limiting provision for disabled motorists. | | |

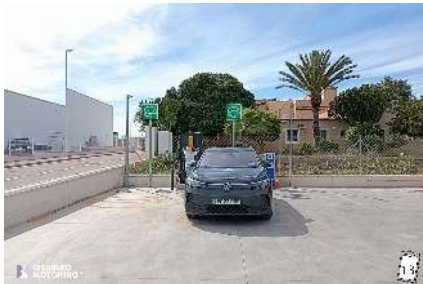
| Accessibility thoughts - Located beside a Burger King, this charging location benefits from nearby facilities but has several physical accessibility issues. Uneven surfaces, raised kerbs and restricted movement around the charging bay make navigation difficult, particularly for wheelchair users. | | |

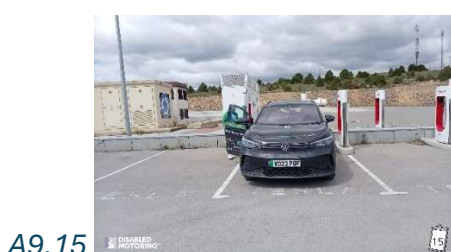
| Accessibility thoughts - The Zunder charging hub offers a quick and efficient charging experience, particularly through QR code payment. However, the absence of pedestrian footpaths and limited safe walking routes reduces accessibility and creates potential safety concerns for disabled users moving between chargers and site facilities. In general, the experience was good. | | |

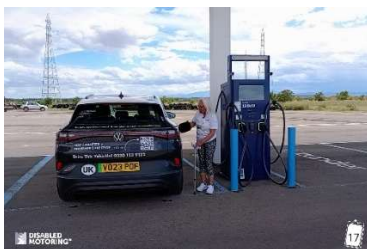
| Accessibility thoughts - This charging location provides good space around the charger and an accessible layout overall. However, the sloping ground, heavy charging cable and cable dragging on the surface creates additional challenges for some disabled users. Overall, a good experience, but with these tweaks it will be much more accessible. | | |

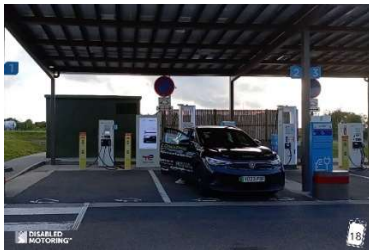
| Accessibility thoughts - Overall, this Zunder charging location offers a positive charging experience with good accessibility and a practical layout. While the facilities perform well, there is still scope to improve accessibility through dedicated accessible charging bays and further refinement of the surrounding infrastructure to support a wider range of users. | | |

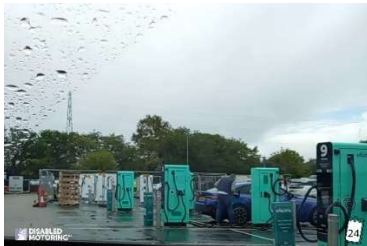
| Accessibility thoughts - This was our least favourite charging stop. The charger was tucked away in the far corner of a car park beside a rubbish area, and the location did not feel particularly safe, with someone looking into parked cars. The bays were narrow, there were no accessible features, the cables dragged across the ground and the screen was difficult to read because of glare. Although payment was straightforward, the overall experience left us feeling uncomfortable. | |
